## **RECORD OF INVESTIGATION INTO DEATH**

Ref: 16/15

*I, Sarah Helen Linton, Coroner, having investigated the death of **Paul Gregory CLIFTON** with an inquest held at the **Perth Coroner's Court, CLC Building, 501 Hay Street, Perth** on **18 May 2015** find that the identity of the deceased person was **Paul Gregory CLIFTON** and that death occurred on **2 June 2013** at **Lancelin Jetty, Lancelin** as a result of **complications arising from immersion (drowning)** in the following circumstances:*

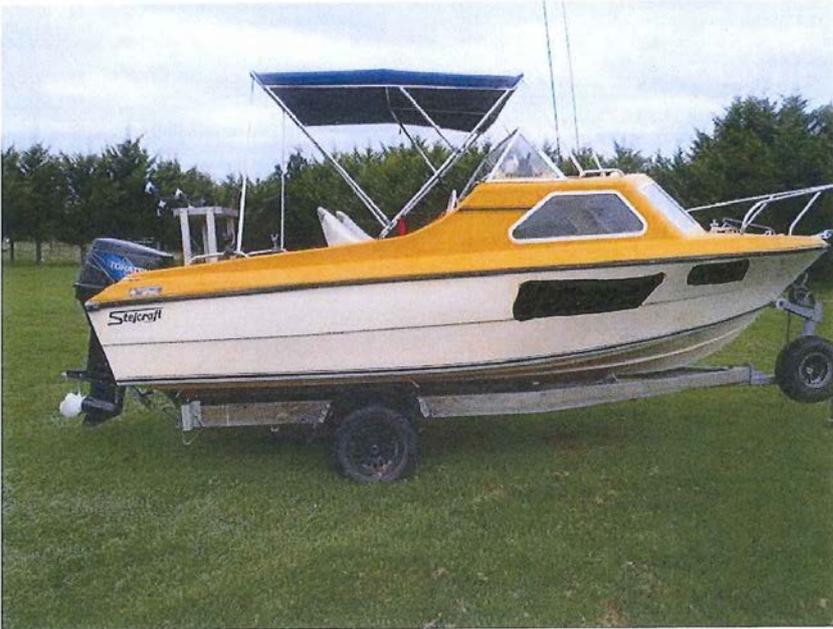
**The photograph to the left (Exhibit 3) depicts a Stejcraft 18 ft. Fibreglass Halfcab with 90 hp Fuel Injected motor and Bimini.**
