Coroner's Court of Western Australia

RECORD OF INVESTIGATION INTO DEATH

Ref: 22/19

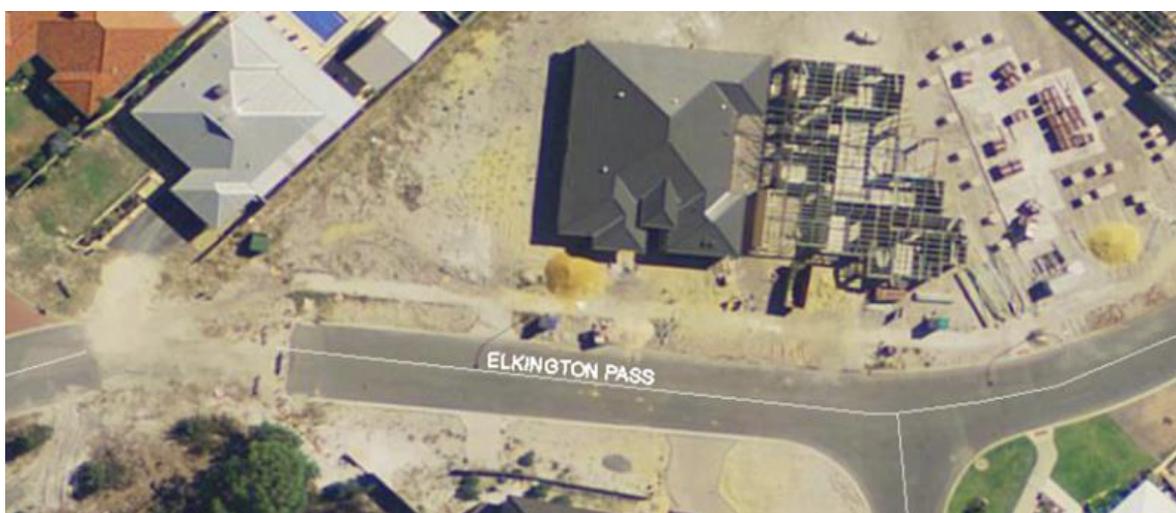
48. The area where the incident occurred was adjacent to a vacant residential block at 21 Elkington Pass (where Mr Bonifazi was working). Elkington Pass had been split into two streets, separated by a sandy area with wooden bollards. It was clear the road for vehicles terminated next to the vacant residential block at 21 Elkington Pass and the concrete footpath also ended, but there was a pedestrian track worn into the dirt that ran from the end of the footpath at 21 Elkington Pass through to the continuation of the roadway on the other side of the bollards.

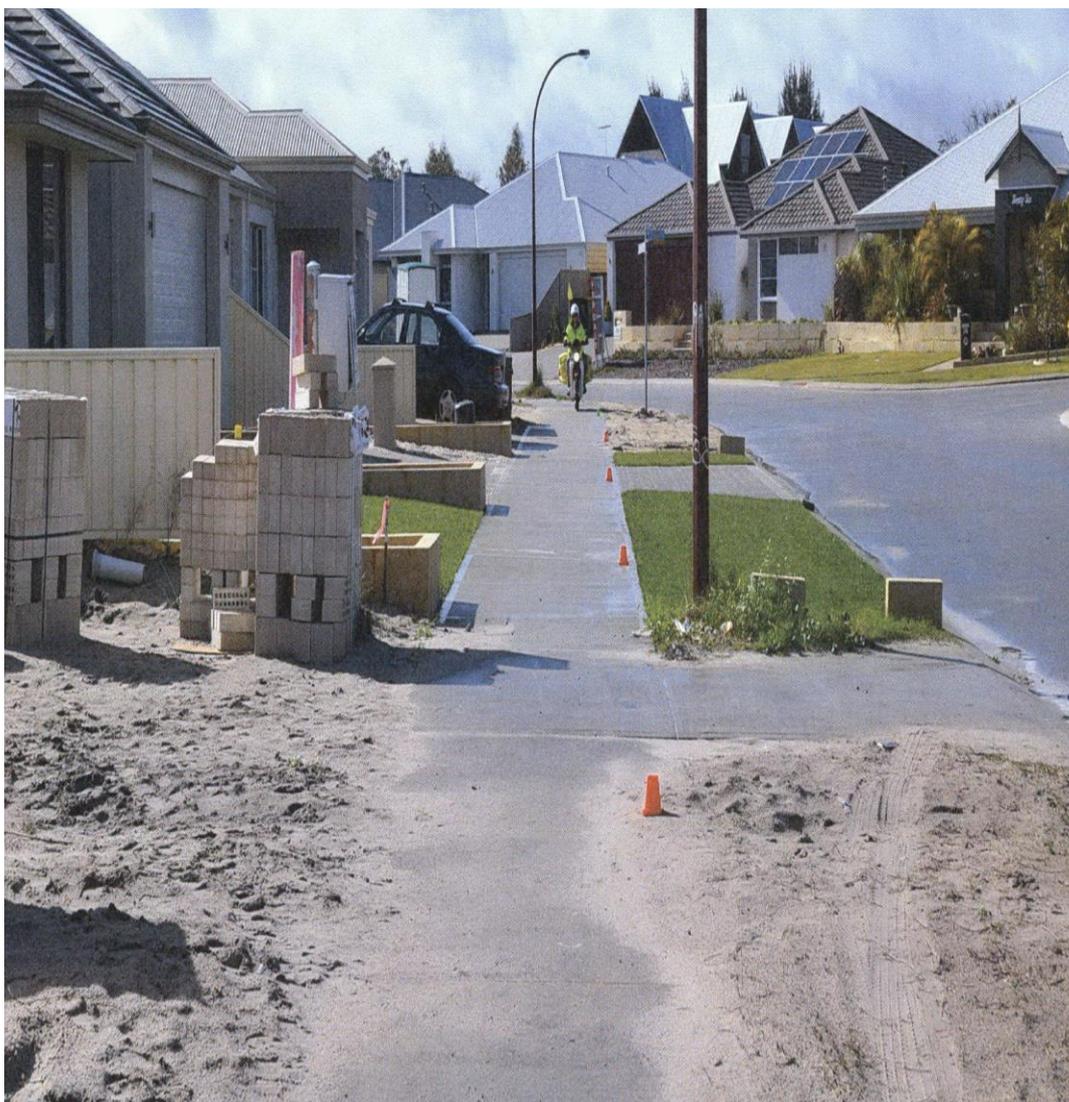
51. The investigating police could not identify any reasonable explanation for why Mr Bonifazi did not see Mr Morgan-Smith, apart from him failing to look down the footpath before reversing. The evidence indicated Mr Morgan-Smith had ridden from the road onto the footpath and then traversed a 30m section of footpath to reach the point where he was struck. There was nothing to obstruct Mr Bonifazi's view of anything up to 50m along the footpath on the immediate approach to the crash site.⁷⁰ A re-creation by police shows Mr Morgan-Smith, dressed as he was and on his motorcycle, would have been highly visible as he approached.⁷¹

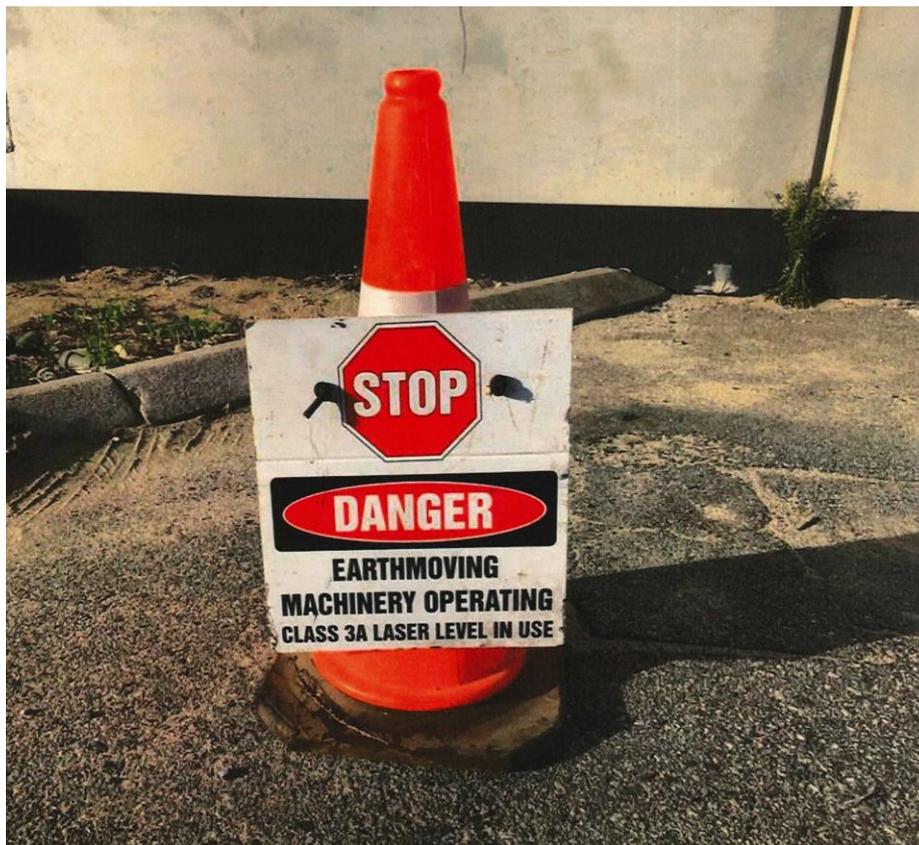
111. Mr Martino provided information at the inquest about other steps his business has taken to reduce risk at worksites where there is a vehicle working near a footpath. They have made up signs to affix to witches' hats to alert pedestrians to the danger presented by earthmoving machinery operating nearby.¹⁴²

112. Mr Martino suggested that in the new residential subdivisions, where there are a lot of tradespeople working on new construction, it might be prudent for similar signs to be put permanently in place to warn people to be cautious due to the possible hazards in the area.¹⁴³
