JURISDICTION : CORONER'S COURT OF WESTERN AUSTRALIA
ACT : CORONERS ACT 1996
CORONER : PHILIP JOHN URQUHART, CORONER
HEARD : 8 - 9 MARCH 2023
DELIVERED : 31 AUGUST 2023
FILE NO/S : CORC 28 of 2020
DECEASED : TWINE, DARREN ROSS

RECORD OF INVESTIGATION INTO DEATH

WorkSafe is investigating an incident, which resulted in a worker sustaining fatal injuries after being hit by a truck at a workplace. At the time of the incident, the worker was positioned in close proximity to the front of the cab of the truck. The driver of the truck did not see the worker prior to setting off.

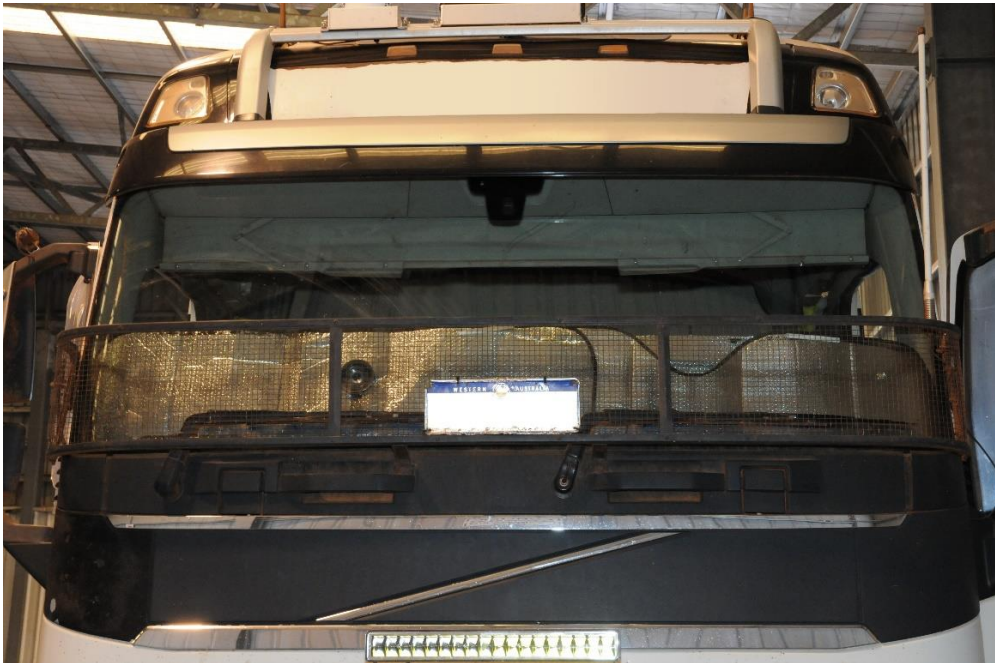
The truck involved in this incident had a non-original, reflective foil visor installed at the base of the windscreen.

Truck with non-original sun visor fitted at base of window.

The installation of a non-original visor at the base of a truck's windscreen increases the size of existing blind spots immediately in front of a truck. This increases the risk of exposure to the hazard of a moving vehicle to other people in the immediate vicinity.

- The sun visor may have further restricted the view of the driver so that the worker was unseen when the vehicle moved off.
- The person conducting a business or undertaking (PCBU), including persons having control of the workplace, not identifying the potential hazards associated with the use of non-original sun visors being installed in the windscreen of trucks.

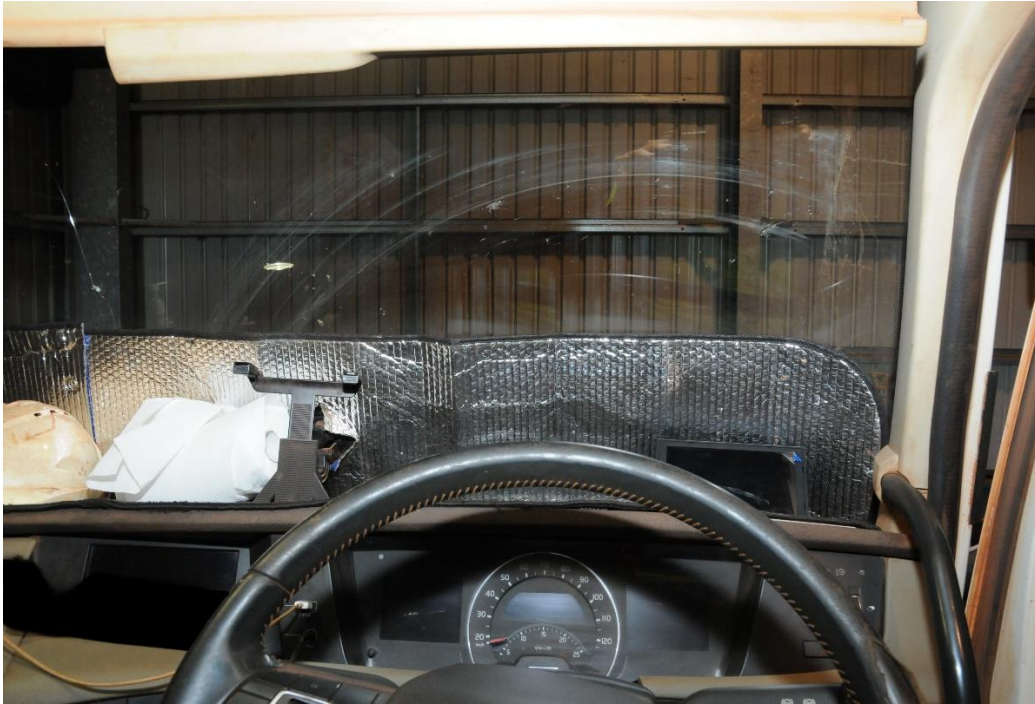
View from cab of truck with non-original sun visor fitted.

From inside the cab, trucks generally have restricted visibility ('blind spots') of some areas around the vehicle. These blind spots, which are much larger than in other vehicles, are a hazard to truck drivers and other people in close proximity to the trucks.
